# Manhole Inspection Summary

Manhole # S29II1036MH

**Location** Address: **OVERHILL UNIVERSITY**

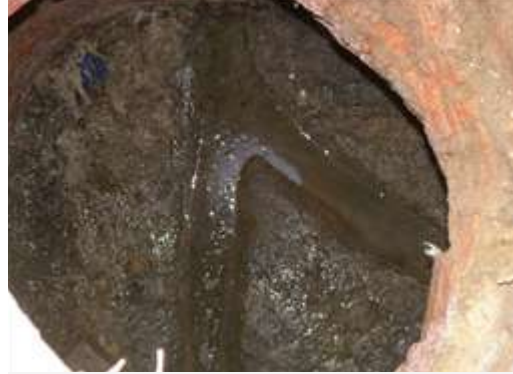
Top View

Evidence of surcharge - Bench debris.

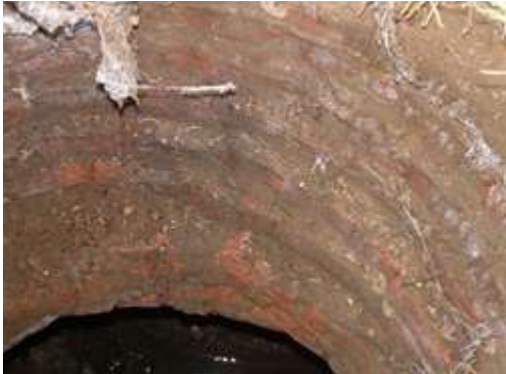
Defect

Adjustment root intrusion and infiltration.  
Corbel deterioration and infiltration.

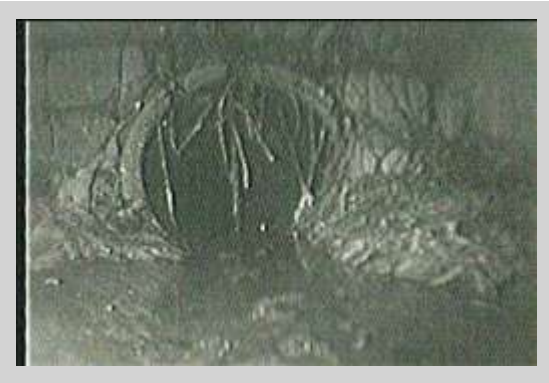
### 6 in. Circular Gravity Sewer Pipe Out @ 12 O'Clock

Infiltration: **Evidence** Pipe Seal Cond: **Roots**

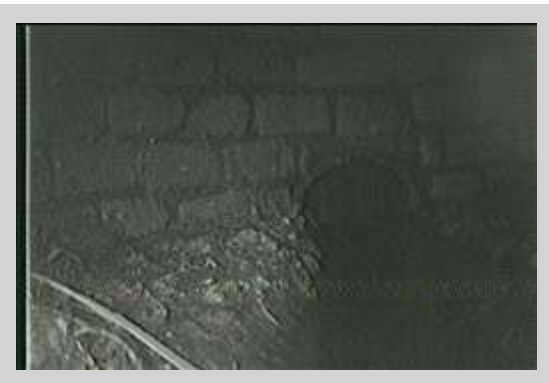
### 6 in. Circular Gravity Sewer Pipe In @ 3 O'Clock

Infiltration: **Evidence** Pipe Seal Cond: **Unknown**

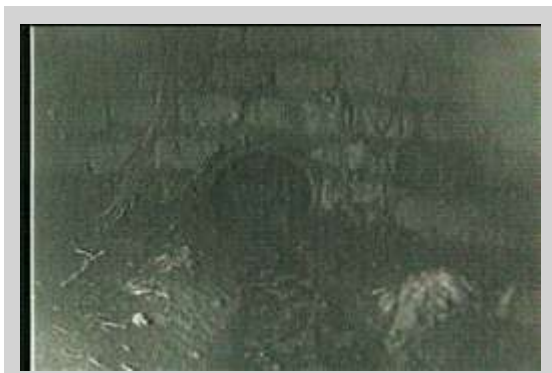
6 in. Circular Gravity Sewer

Barrel deterioration, root intrusion and infiltration.

Infiltration: **Evidence**

Pipe Seal Cond: **Roots**
